# PolyArmor® 490-572

### ▶ **CASE STUDY 1: Metal Roof Restoration**

**PROJECT:** Restore Badly Leaking Corrugated Metal Roof

**OWNER:** Pepsi Cola Co., Grand Rapids, Michigan

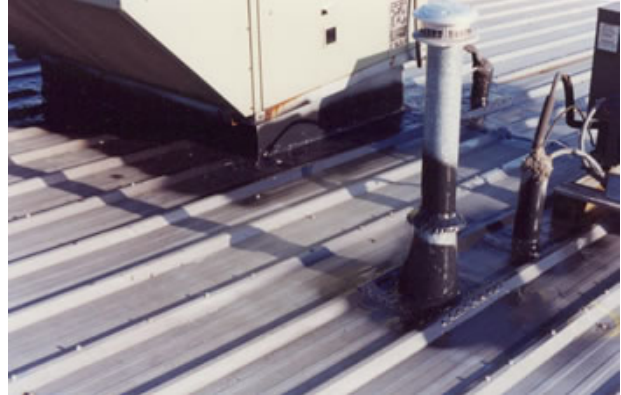
**DISCUSSION:** This corrugated metal style roof was over ten years old at the time of restoration by ReNew. There were over sixty-five separate leaks by count prior to re-sealing. When done, there was one very small drip that was easily repaired. Over two million sq. ft. of metal roof has been restored by ReNew since 1992 using POLYARMOR coatings exclusively. (covered by U. S. Patent 5,392,583)

- ◆ Power washed - 3000 psi.
- ◆ Wirewheel brushed all areas to be coated - removed all loose rust.
- ◆ Tightened all loose screws.
- ◆ Acid etched all areas to be coated.
- ◆ Applied proprietary galv. primer.
- ◆ Sealed all horizontal and vertical lap joints, all screw heads and all protrusions with POLYARMOR® 490-572 plural under private brand.
- ◆ Overcoated all areas with aluminized asphaltic paint
